Identifying the Twisted Wreckage of a Boxcar on the Georgetown Branch of the B&O

by Ben Sullivan - ben.sullivan75@gmail.com - 9/2021

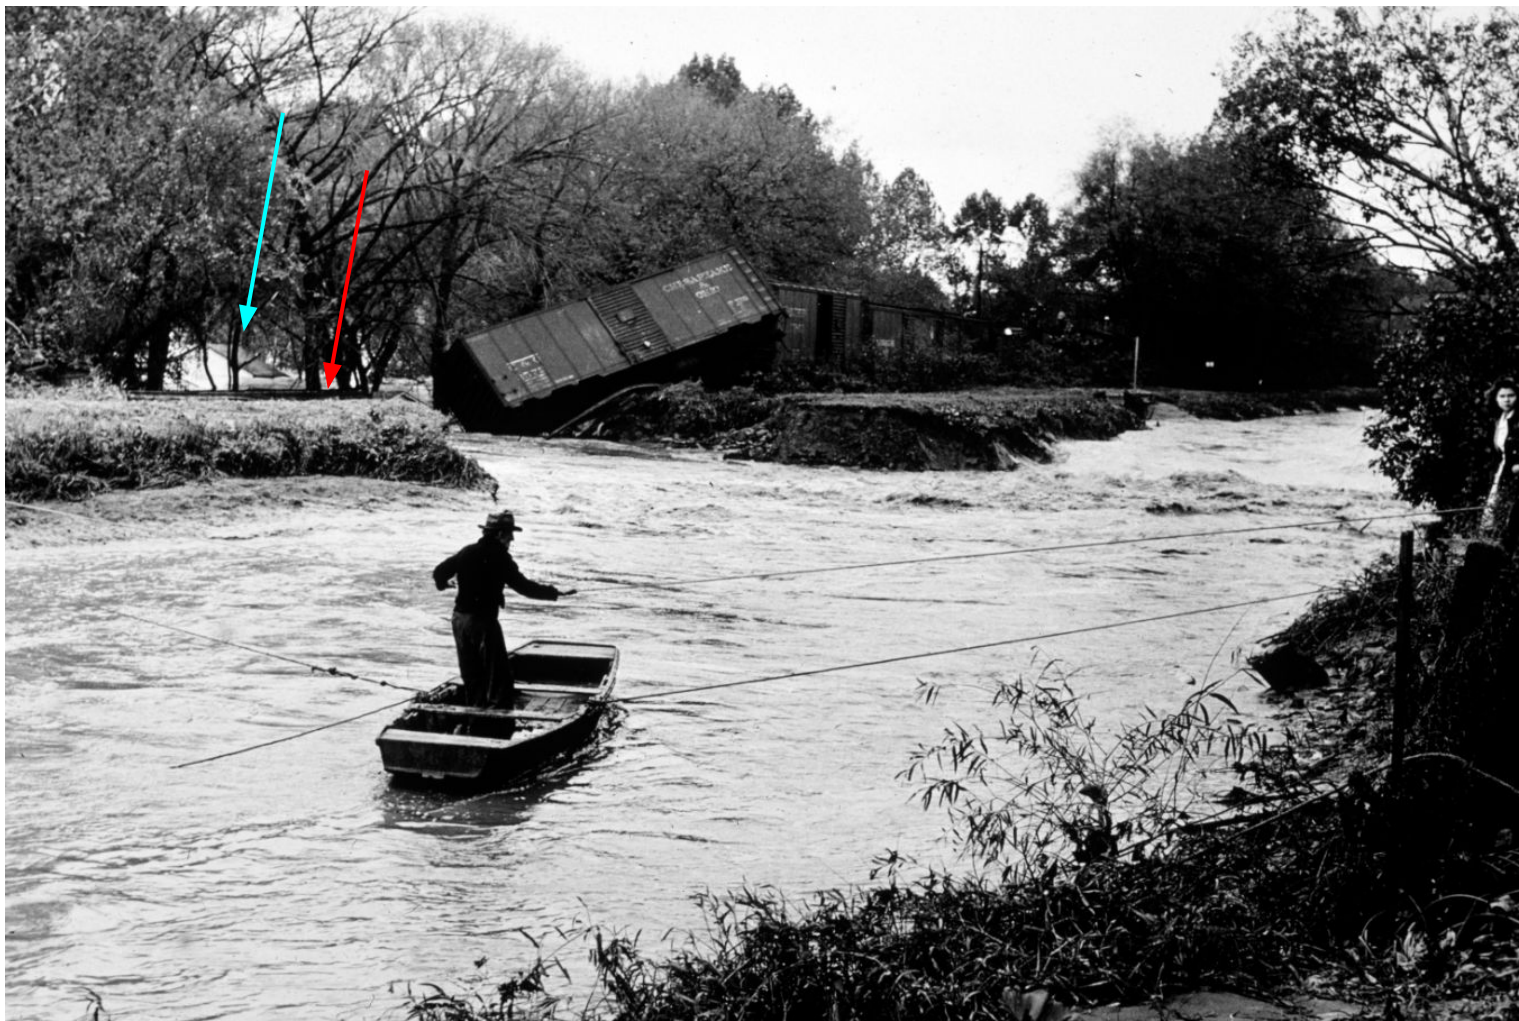
Fletcher's
Boathouse,
10/17/1942
Collection of
Robert Truax, W.
Duvall, scanned
by myself

The boxcar in
question (**red arrow**)
is just barely visible
(the roof) beyond the
breach of the canal
towpath.

In this photo, you can
see where the C&O
Canal was breached and
water is rushing
down to the Potomac
River, past Fletcher's
Boathouse (**blue
arrow**) below.

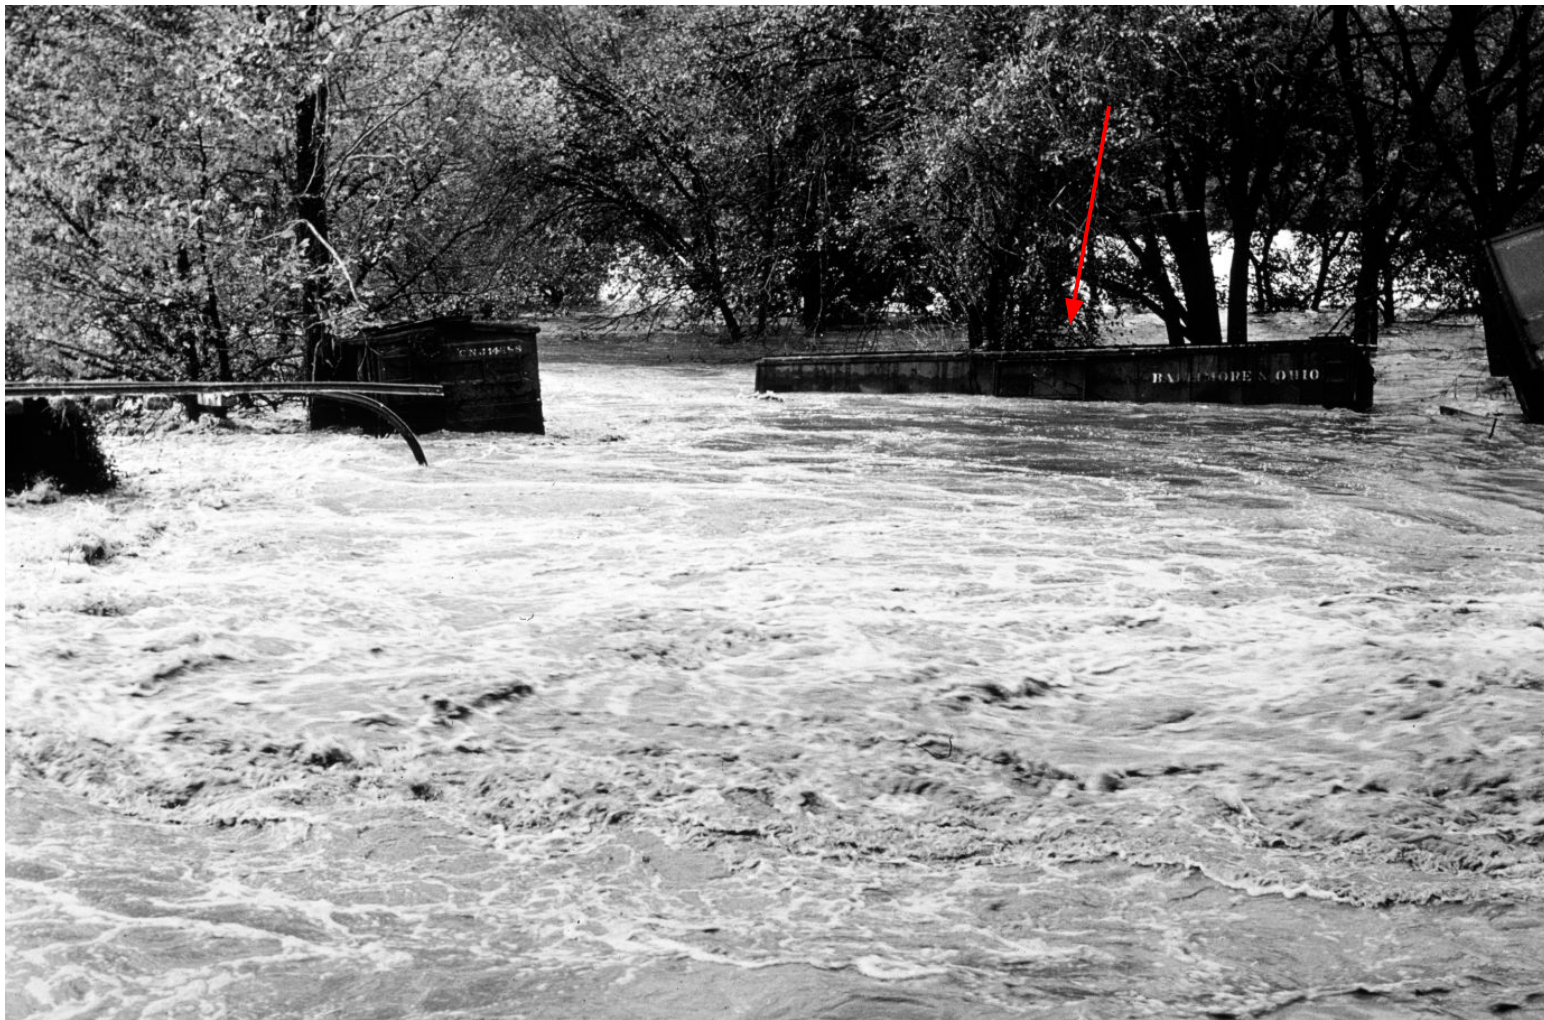
Fletcher's
Boathouse,
10/17/1942
Collection of
Robert Truax, W.
Duvall, scanned
by myself

The boxcar in
question is
submerged in the
rushing
floodwaters.

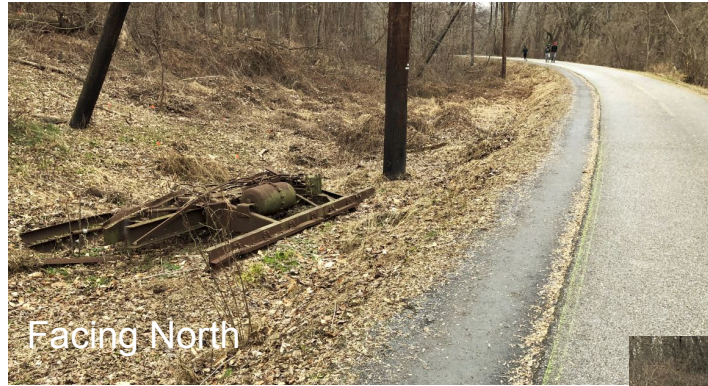
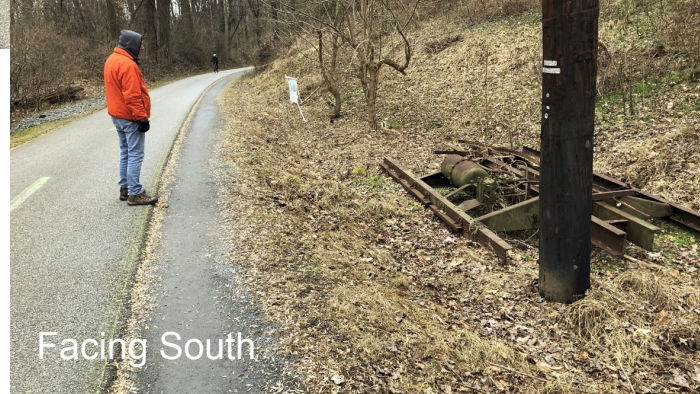
Note the center section of the boxcar is to the west side and the two end sections are off in the woods to the East side.

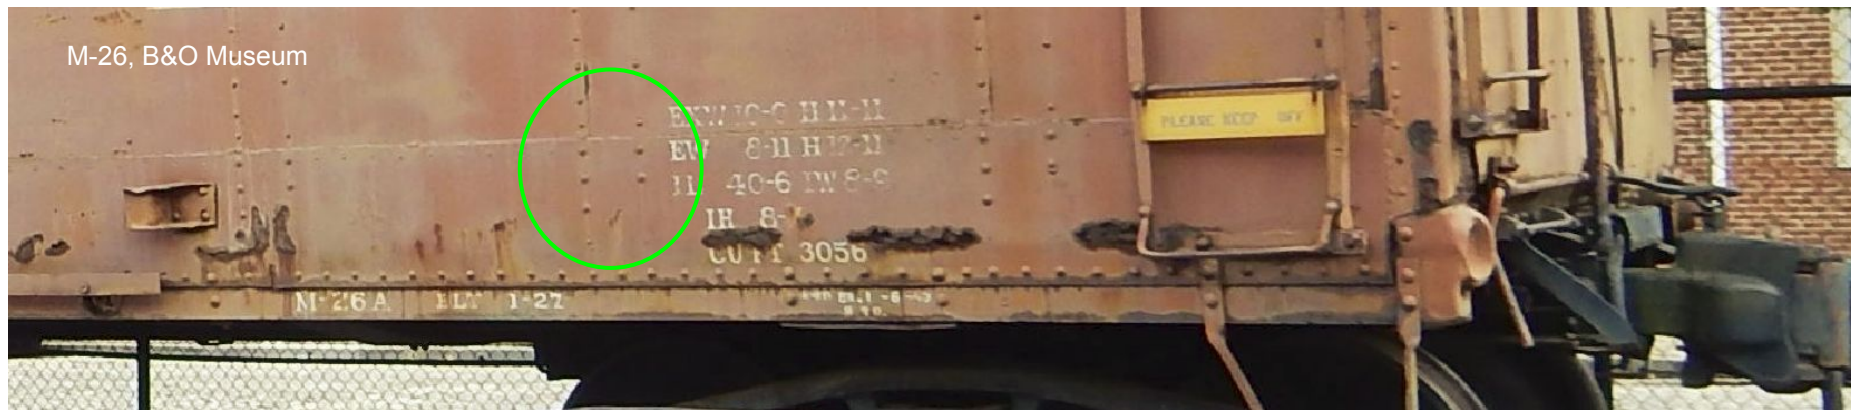
M-26, B&O Museum

Rivet pattern

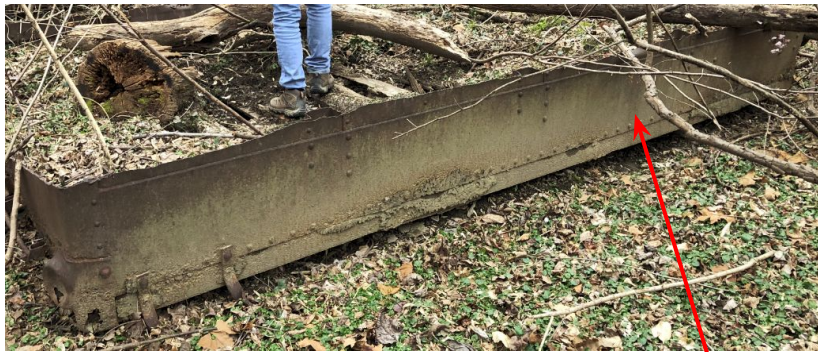
Actual paint remains on the boxcar. This is the only paint I could find still remaining on the car.

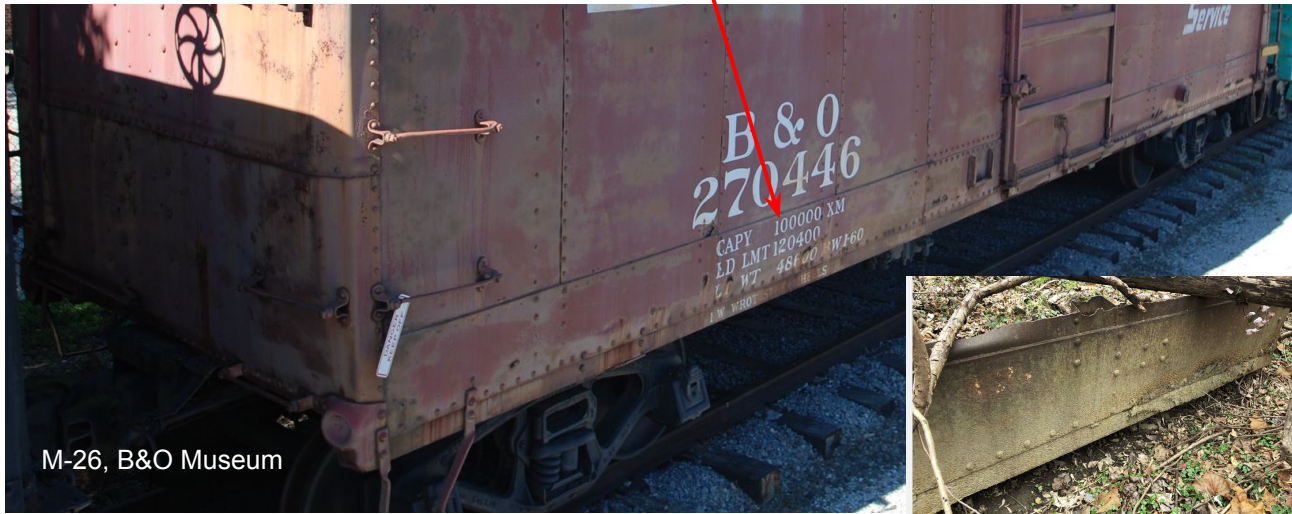
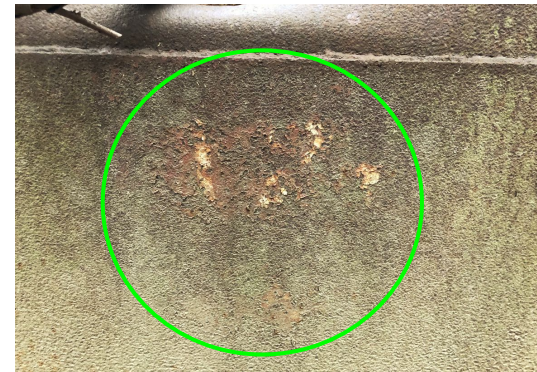
On the prototype, the placement of the "LD LMT" stencil varied - sometimes it was in the middle of the plate and other times near the top, seen here. To me, this resembles the "12" of "120400."

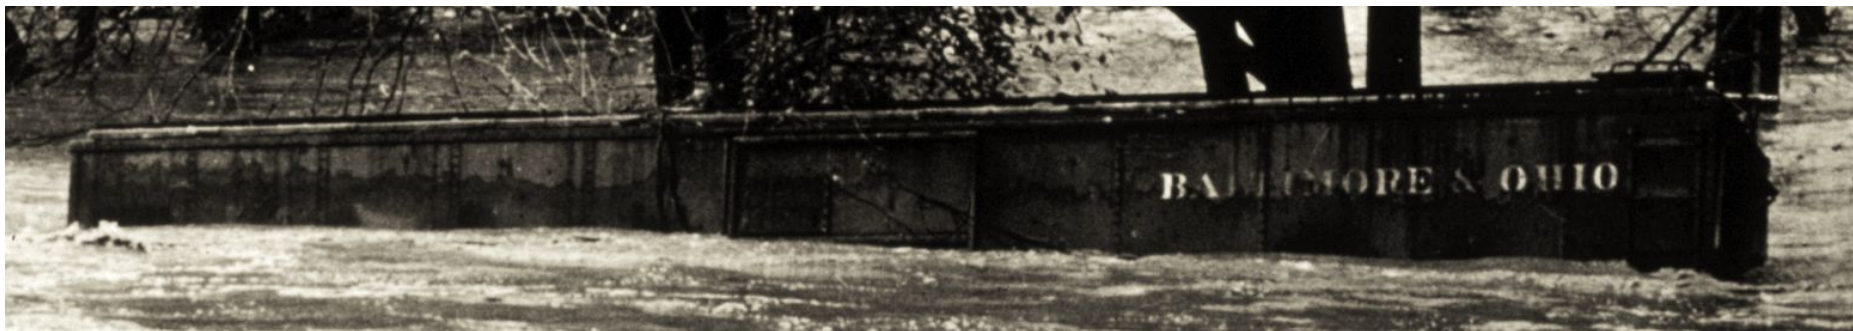
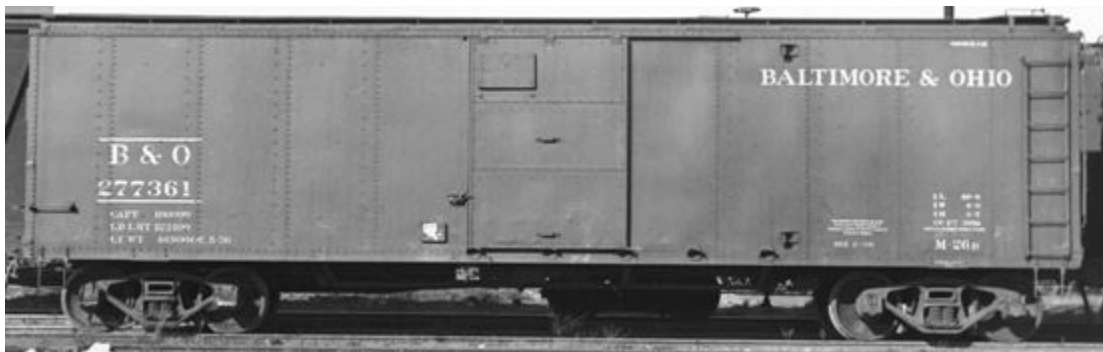
From [Protocraft](#) site

[Protocraft produces a decal set for these cars with a nice historic breakdown:](#)

Series 265000-266999, 2000 cars, Pullman Car & Manufacturing Co, Lot 5387, delivered May 1925, Class M-26
Series 267000-267999, 1000 cars, Bethlehem Steel Car Co, Lot 2435, delivered February 1926, Class M-26B
Series 268000-268999, 1000 cars, Standard Steel Car Co, delivered 1925-26, Class M-26A
Series 269000-269999, 1000 cars, Bethlehem Steel Car Co, Lot 2680, delivered August 1926, Class M-26A
Series 270000-270499, 500 cars, Standard Steel Car Co, delivered December 1926, Class M-26A
Series 270500-270999, 500 cars, American Car & Foundry, Lot 424, delivered 1927, Class M-26A
Series 271000-271499, 500 cars, Pressed Steel Car Company, delivered 1927, Class M-26A
Series 271500-272499, 1000 cars, Baltimore Car & Foundry, delivered May-July 1928, Class M-26C
Series 272500-273499, 1000 cars, Baltimore Car & Foundry, delivered September-October 1928, Class M-26D Duryea u/f
Series 273500-273749, 250 cars, Baltimore Car & Foundry, delivered February-March 1929, Class M-26D Duryea u/f

Series 273750-274499, 750 cars, Baltimore Car & Foundry, delivered January-March 1929, Class M-26D Duryea u/f
Series 274500-276499, 2000 cars, Baltimore Car & Foundry, delivered Aug 1929/Jan 1930, Class M-26D Duryea u/f
Series 276500-277999, 1500 cars, Baltimore Car & Foundry, delivered January-March 1930, Class M-26D Duryea u/f
Series 278000-278999, 1000 cars, Baltimore Car & Foundry, delivered March 1931, Class M-26E Duryea u/f
